Appendix A: Northern Portions of Lake Rescue, Ludlow, Vermont 05149

Appendix E: Existing Conditions: Round Pond (Site 1)

<p>LAKE RESCUE ASSOCIATION LAKE RESCUE DREDGING PROJECT Town of Ludlow, Windsor County, Vermont</p>	<p>DETAILS</p> <p>Date: 4/12/12 Base Map(s): Scale: 1"=30' Contour Interval: 0.5' Datum: MLL Project Manager: JLL Drawn by: WJS</p>	<p>LEGEND</p> <p>— Extents of Dredging — -3.5 Lake Bottom Contours</p>	<p>1) Depth to lake bottom contours based on Lake Levels as observed on 4/12/12. 2) Lake was 5-6 inches down average level on date of survey</p>
	<p>EXISTING CONDITIONS MAP Survey Area North of The Narrows</p>

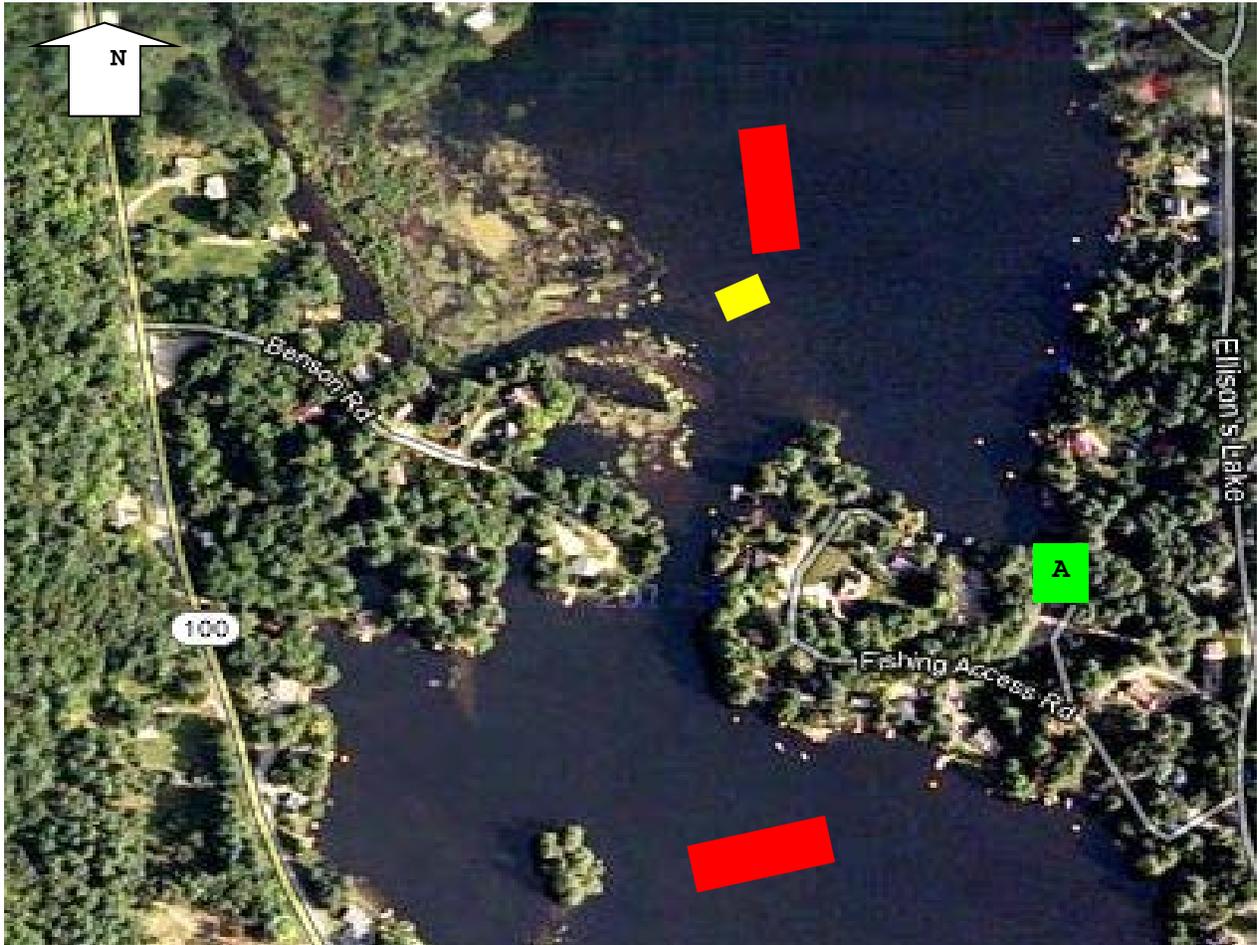
Appendix B: GOOGLE MAP SHOWING PROPOSED AREAS OF DREDGING AND DEWATERING.

The green box shows the proposed dewatering site at the state fishing access.

The yellow box shows the approximate location where the pontoon boat hung up on new sediment during the October, 2011 tour with ANR staff. Previous to Irene, such boats could enter the river.

The solid red boxes show the approximate locations of two new sandbar areas.

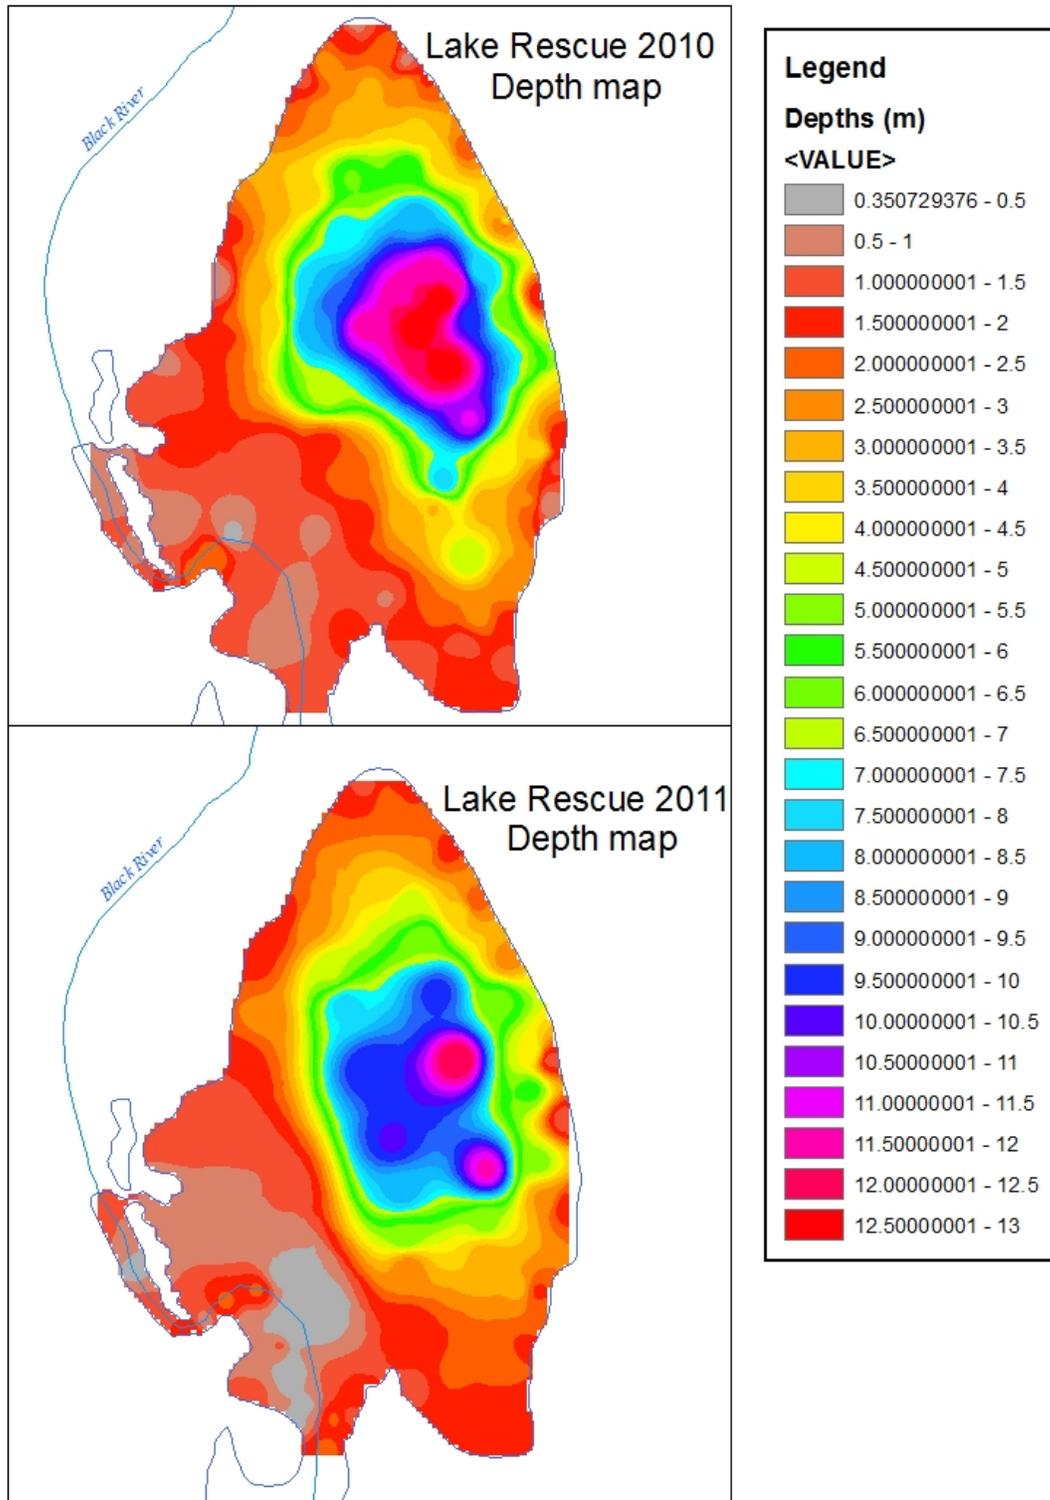
Figure 1. Lake Rescue depth maps 2010 and 2011 for all depths

Figure 1 displays Round Pond before and after the storm for all depths. The shallow areas nearest to inlet have enlarged as shown in gray. The deepest part of the lake displayed some changes as well, but should be interpreted with caution. There were fewer data points in this area than in the shallower areas, and the apparent change may be an artifact of the smaller data set on which to base the interpolation.

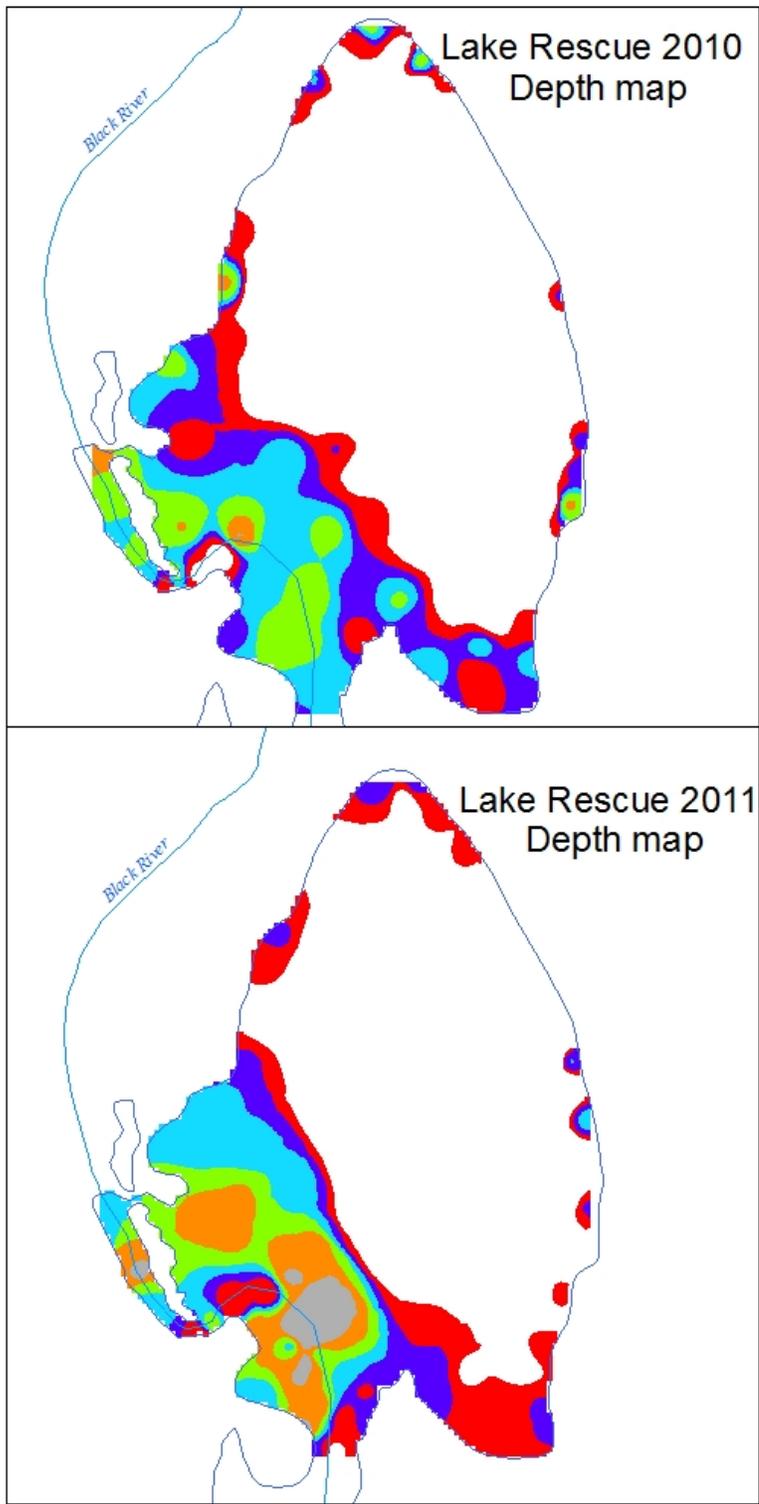
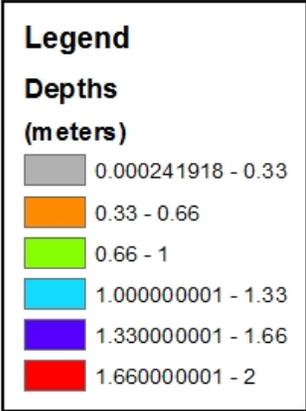
Figure 2. Lake Rescue depth maps 2010 and 2011 for two meters and shallower.

Figure 2 display just those areas that were two meters deep or shallower. In this view, there is greater precision in the areas that may pose a challenge to navigation. This map has increments of approximately 0.33 meters (~ 1 foot). The two shallowest categories, gray and orange, have increased in area from 2010 to 2011.

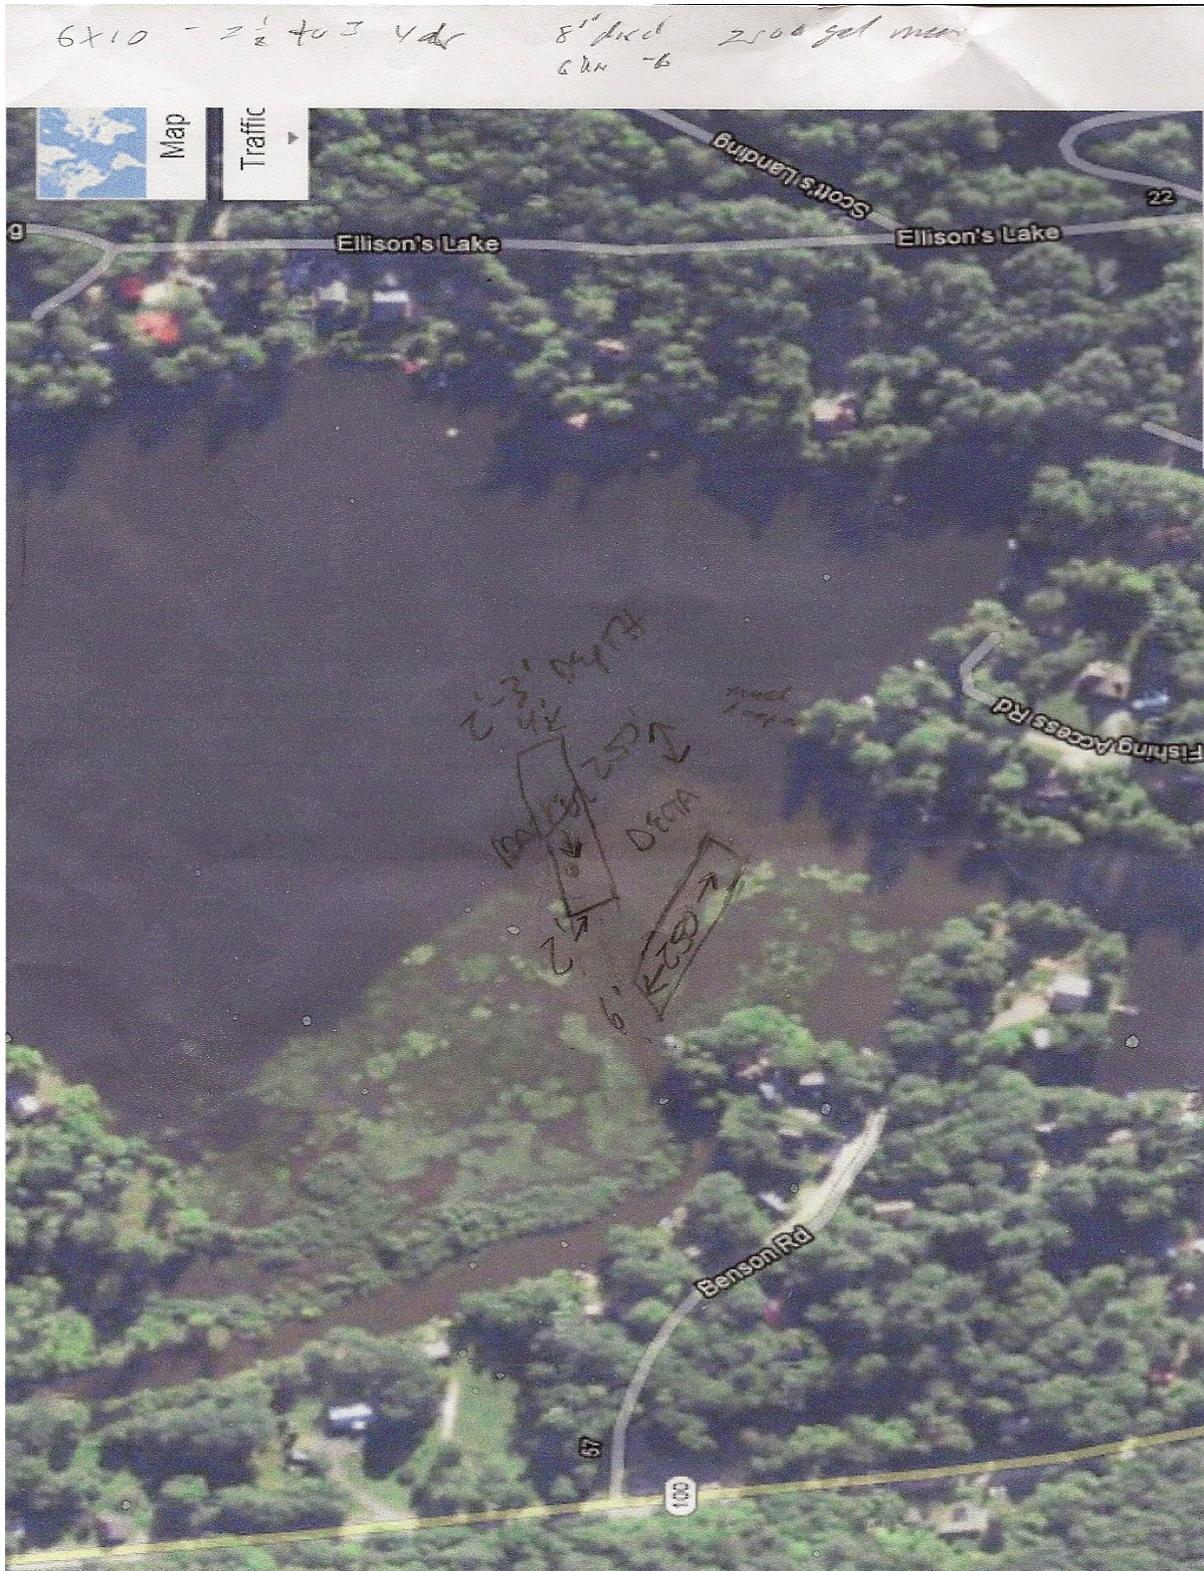
Appendix D: Under Water Survey, April 4, 2012 by Chris Sheldon
Round
Pond

- D. In early April, LRA engaged the services of our milfoil diver for an underwater survey of the two sites. He was selected because of his intimate knowledge of the shallower areas of the lake based on eight years of dives looking for milfoil. He found significant areas where new sediment had made water levels less than three feet in both sites. His mapping of the sites (Appendix D, page 11) is consistent with the LRA survey and that completed by VTDEC in Round Pond.

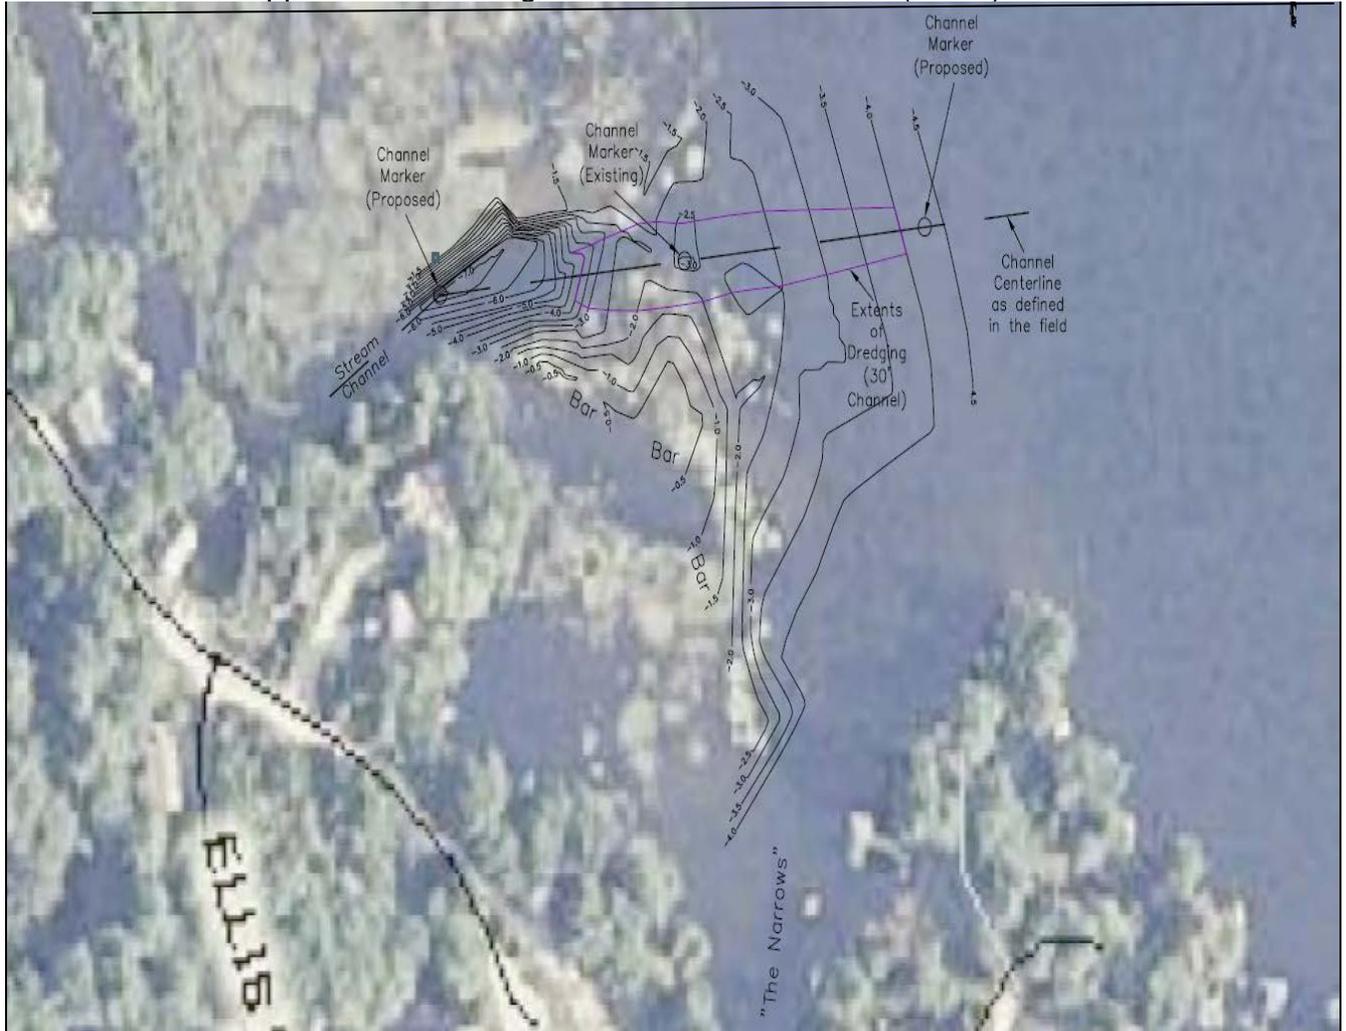
- E. Under a contract with Griggs-Lang Consulting Geologists, Inc. a formal survey was conducted April 12th at both the main lake and Round Pond sites. The resulting maps (Appendix E, page 13) clearly show the extent of the problem in the channel leading from the river and extending into Round Pond. To restore navigability in that area, the report recommends removing 485 cubic yards of sediment to a width of 30 feet and a minimum depth of 4 feet.

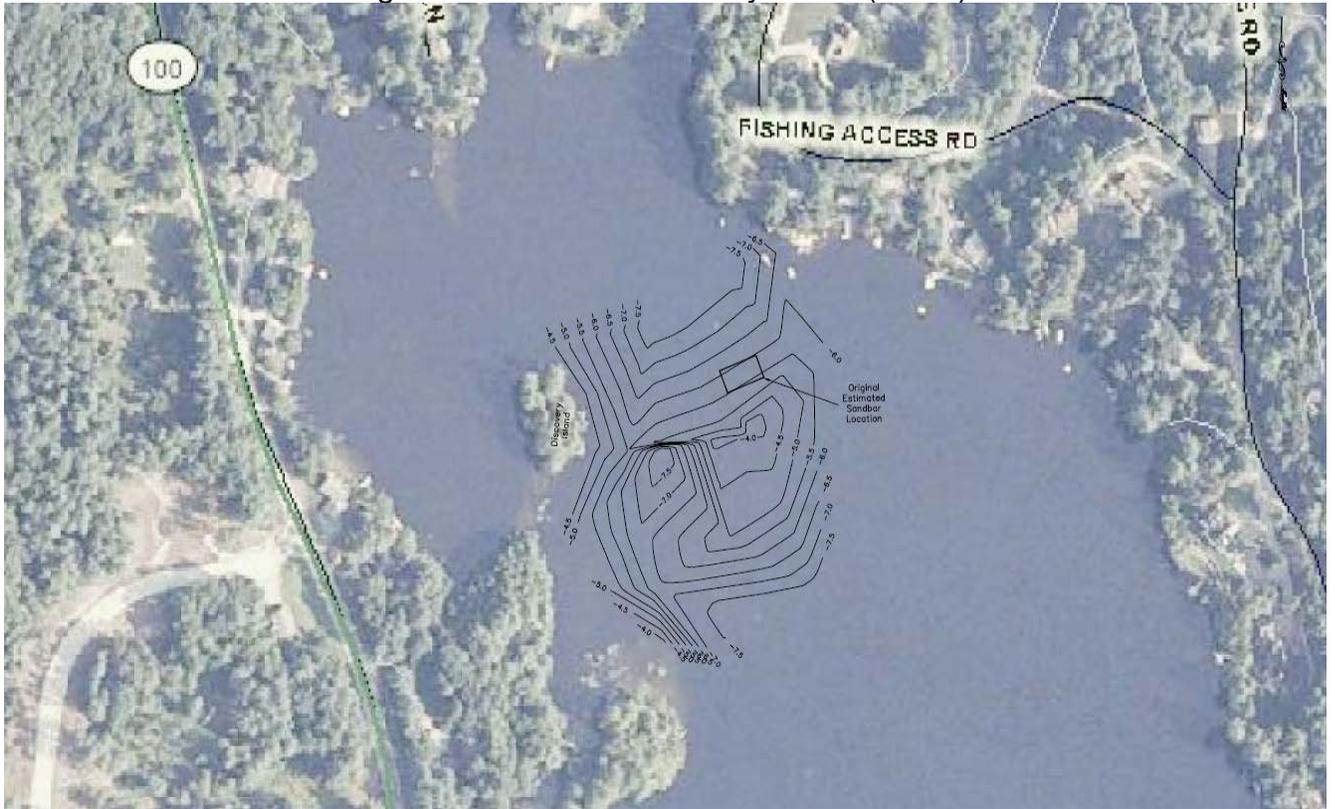
Existing Conditions: Off Discovery Island (Site 2)

Surprisingly, the geologist did not find any depth levels below four feet in site 2, even though they had been found and stood upon by the milfoil diver less than two weeks previously. This clear evidence of continued movement of sediment is one reason for our request to re-do the same survey in the spring of 2013 with the intent of removing additional sediment that impedes navigability in these areas of the lake.

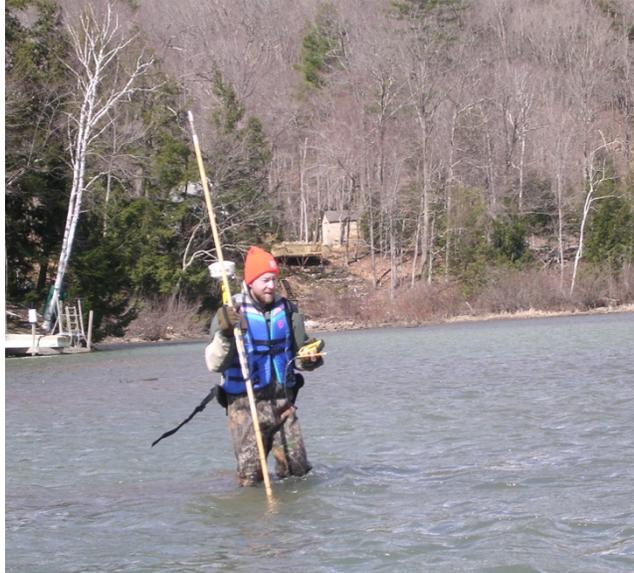
Standing in the
Channel

Since much of the survey was conducted by walking around on site 1, it was possible to test the firmness of the sediment. In areas where sediment has built up over time, it is firm and easy to walk on. However, in the recently deposited areas on the edges of the channel and in the channel at some points, it is soft and unstable (see pictures in Appendix F, page 15), It is also important to note that the recommended channel
