**Lake Rescue
Town of Ludlow, Windsor County, Vermont**

BATHYMETRIC INVESTIGATION

November 26, 2018

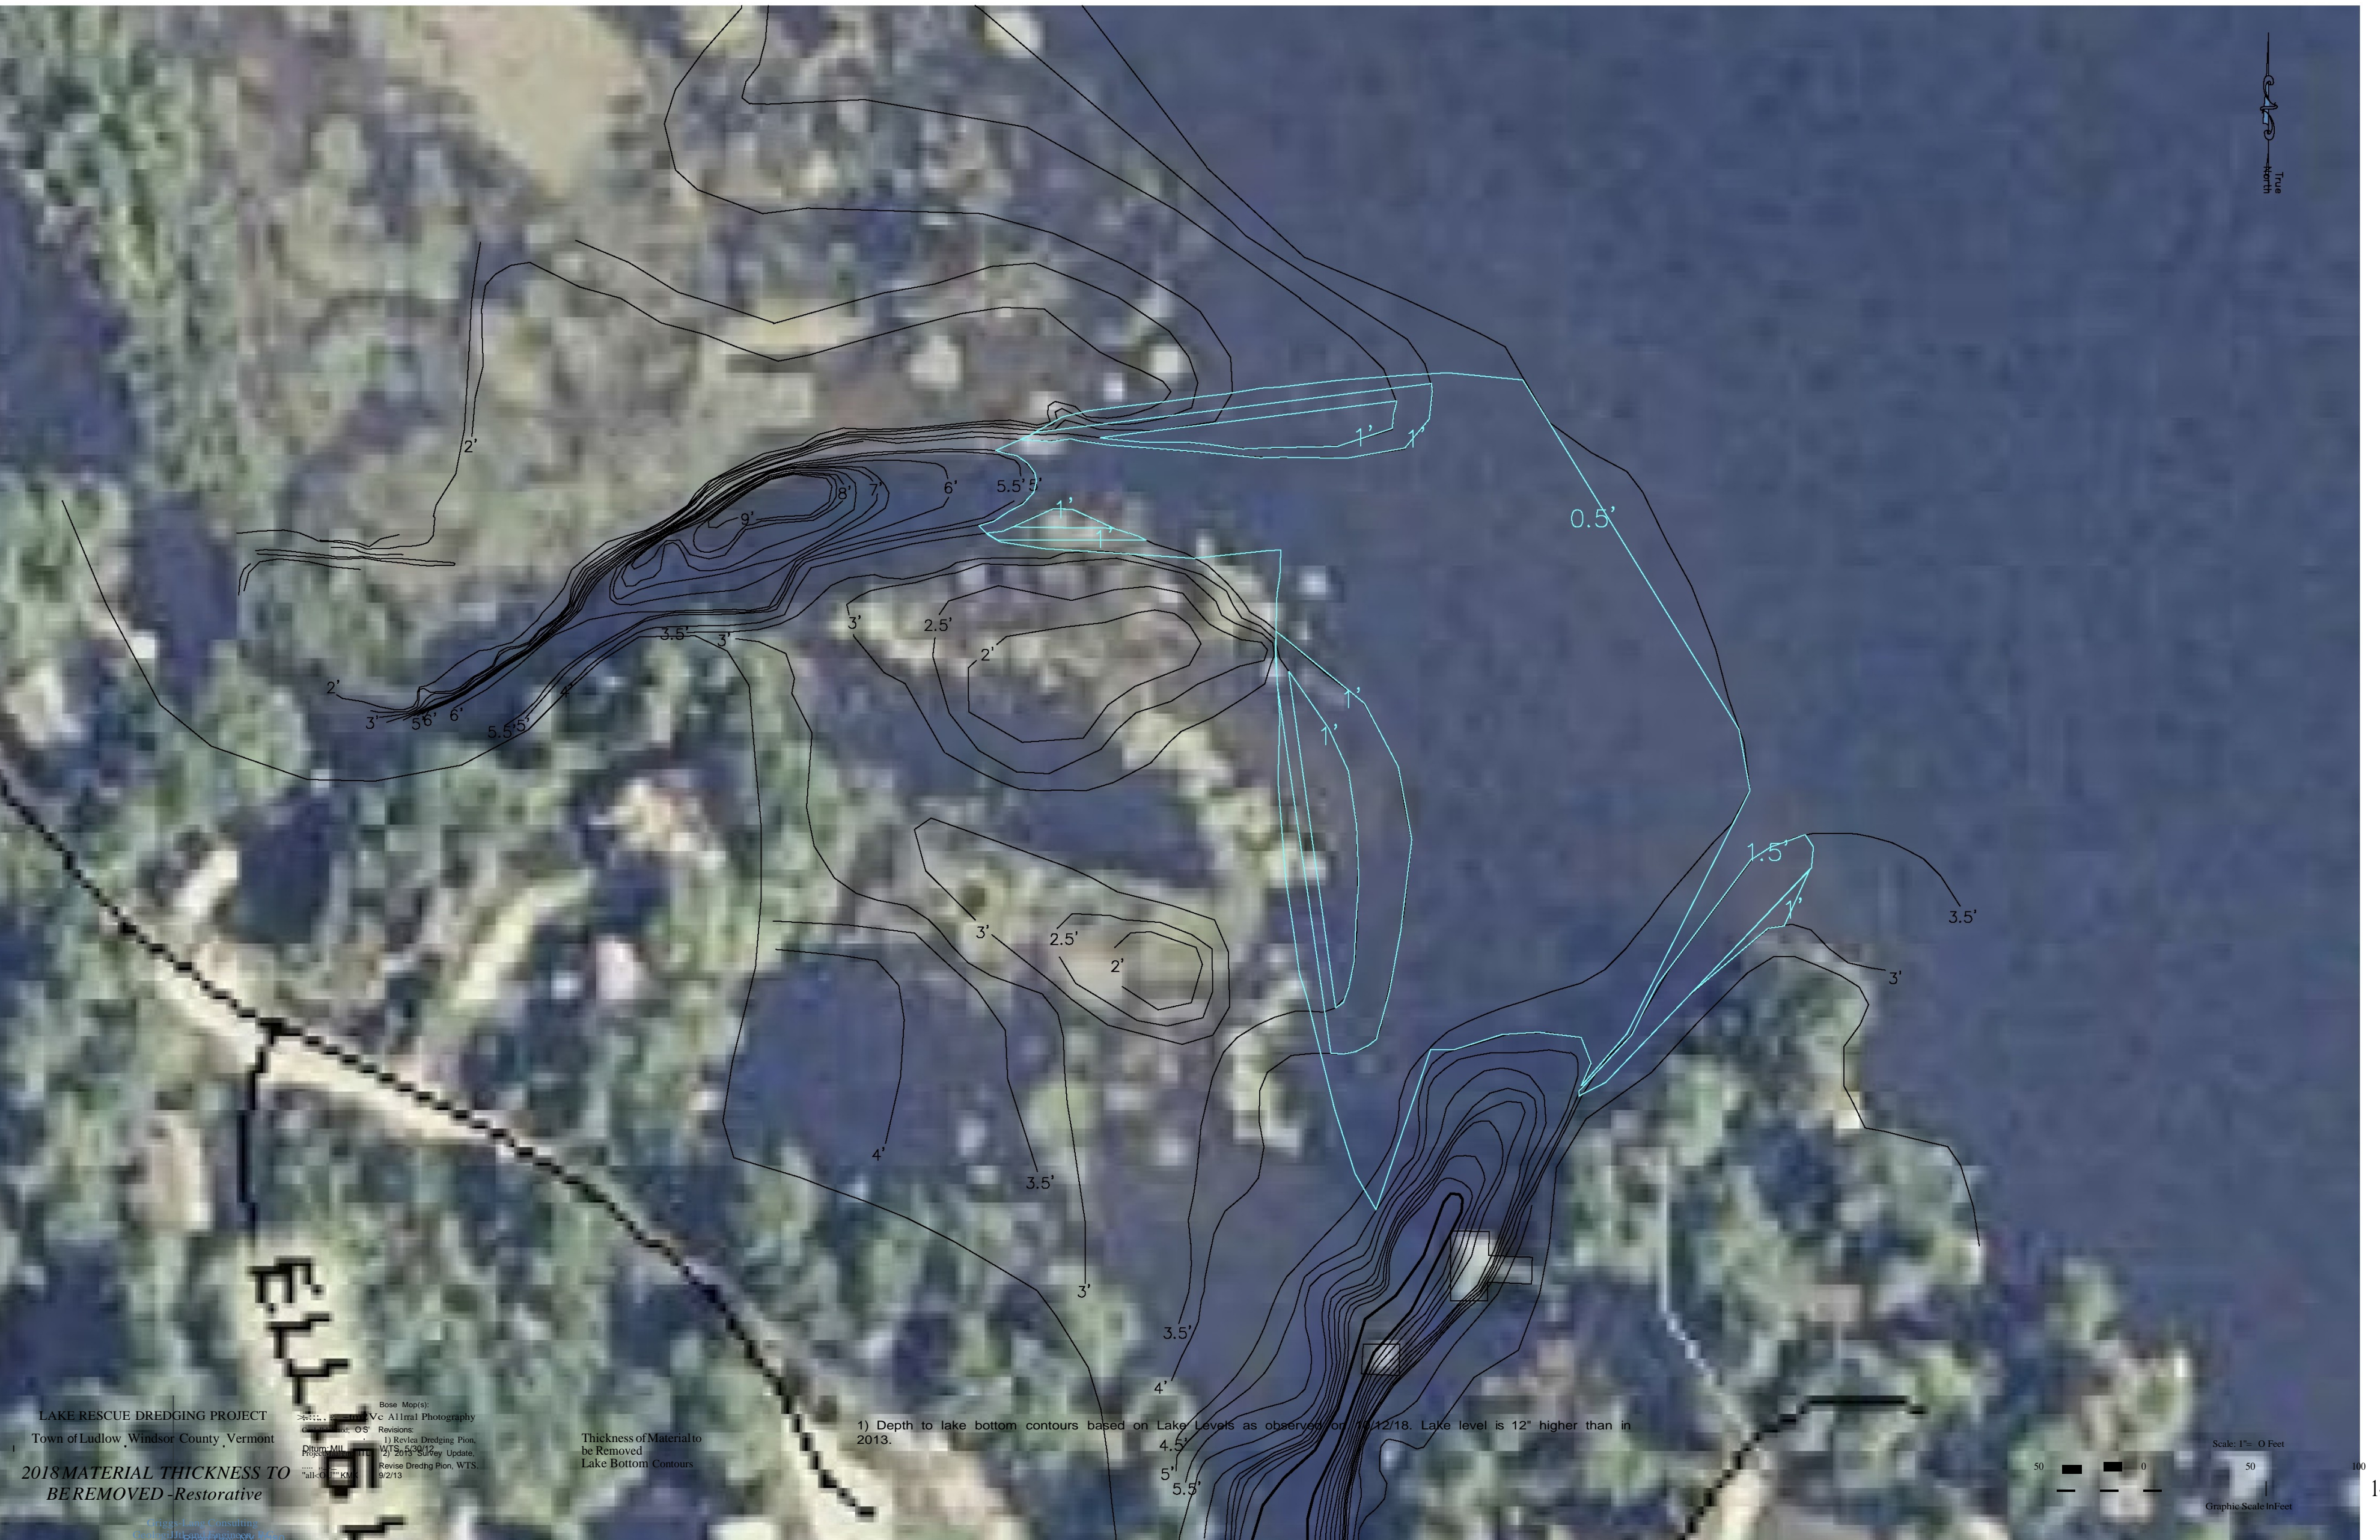
CHART C

The mouth of the Black River and north of the Narrows has filled in between 6 and 18 inches since the restoration was performed in 2013. There are large areas that have a depth of less than 4 feet after adjusting for the differences in lake level at the time of observation. After considering the effect of differences in the lake levels on the observation dates, any area marked by a 2018 contour line of [5 feet or less] would have a depth less than 4 feet compared to the 2012/13 lake level. (See Chart B)

Since the lake levels are approximately 12 inches higher Griggs-Lang recommends dredging to the 5-foot contours *at a minimum* to restore navigation in the river and the Narrows. The estimate of material to be removed to restore the depth of the lake in the general area of the 2012 Application is 1,980 cubic yards. The area of the estimate includes all of the area in the 2012 Application and additional area south of the river channel and north of the Narrows. The restoration would remove between 6 to 12 inches of sediment from the bottom of the proposed area, which covers approximately 69,017 square feet. (See Chart C)

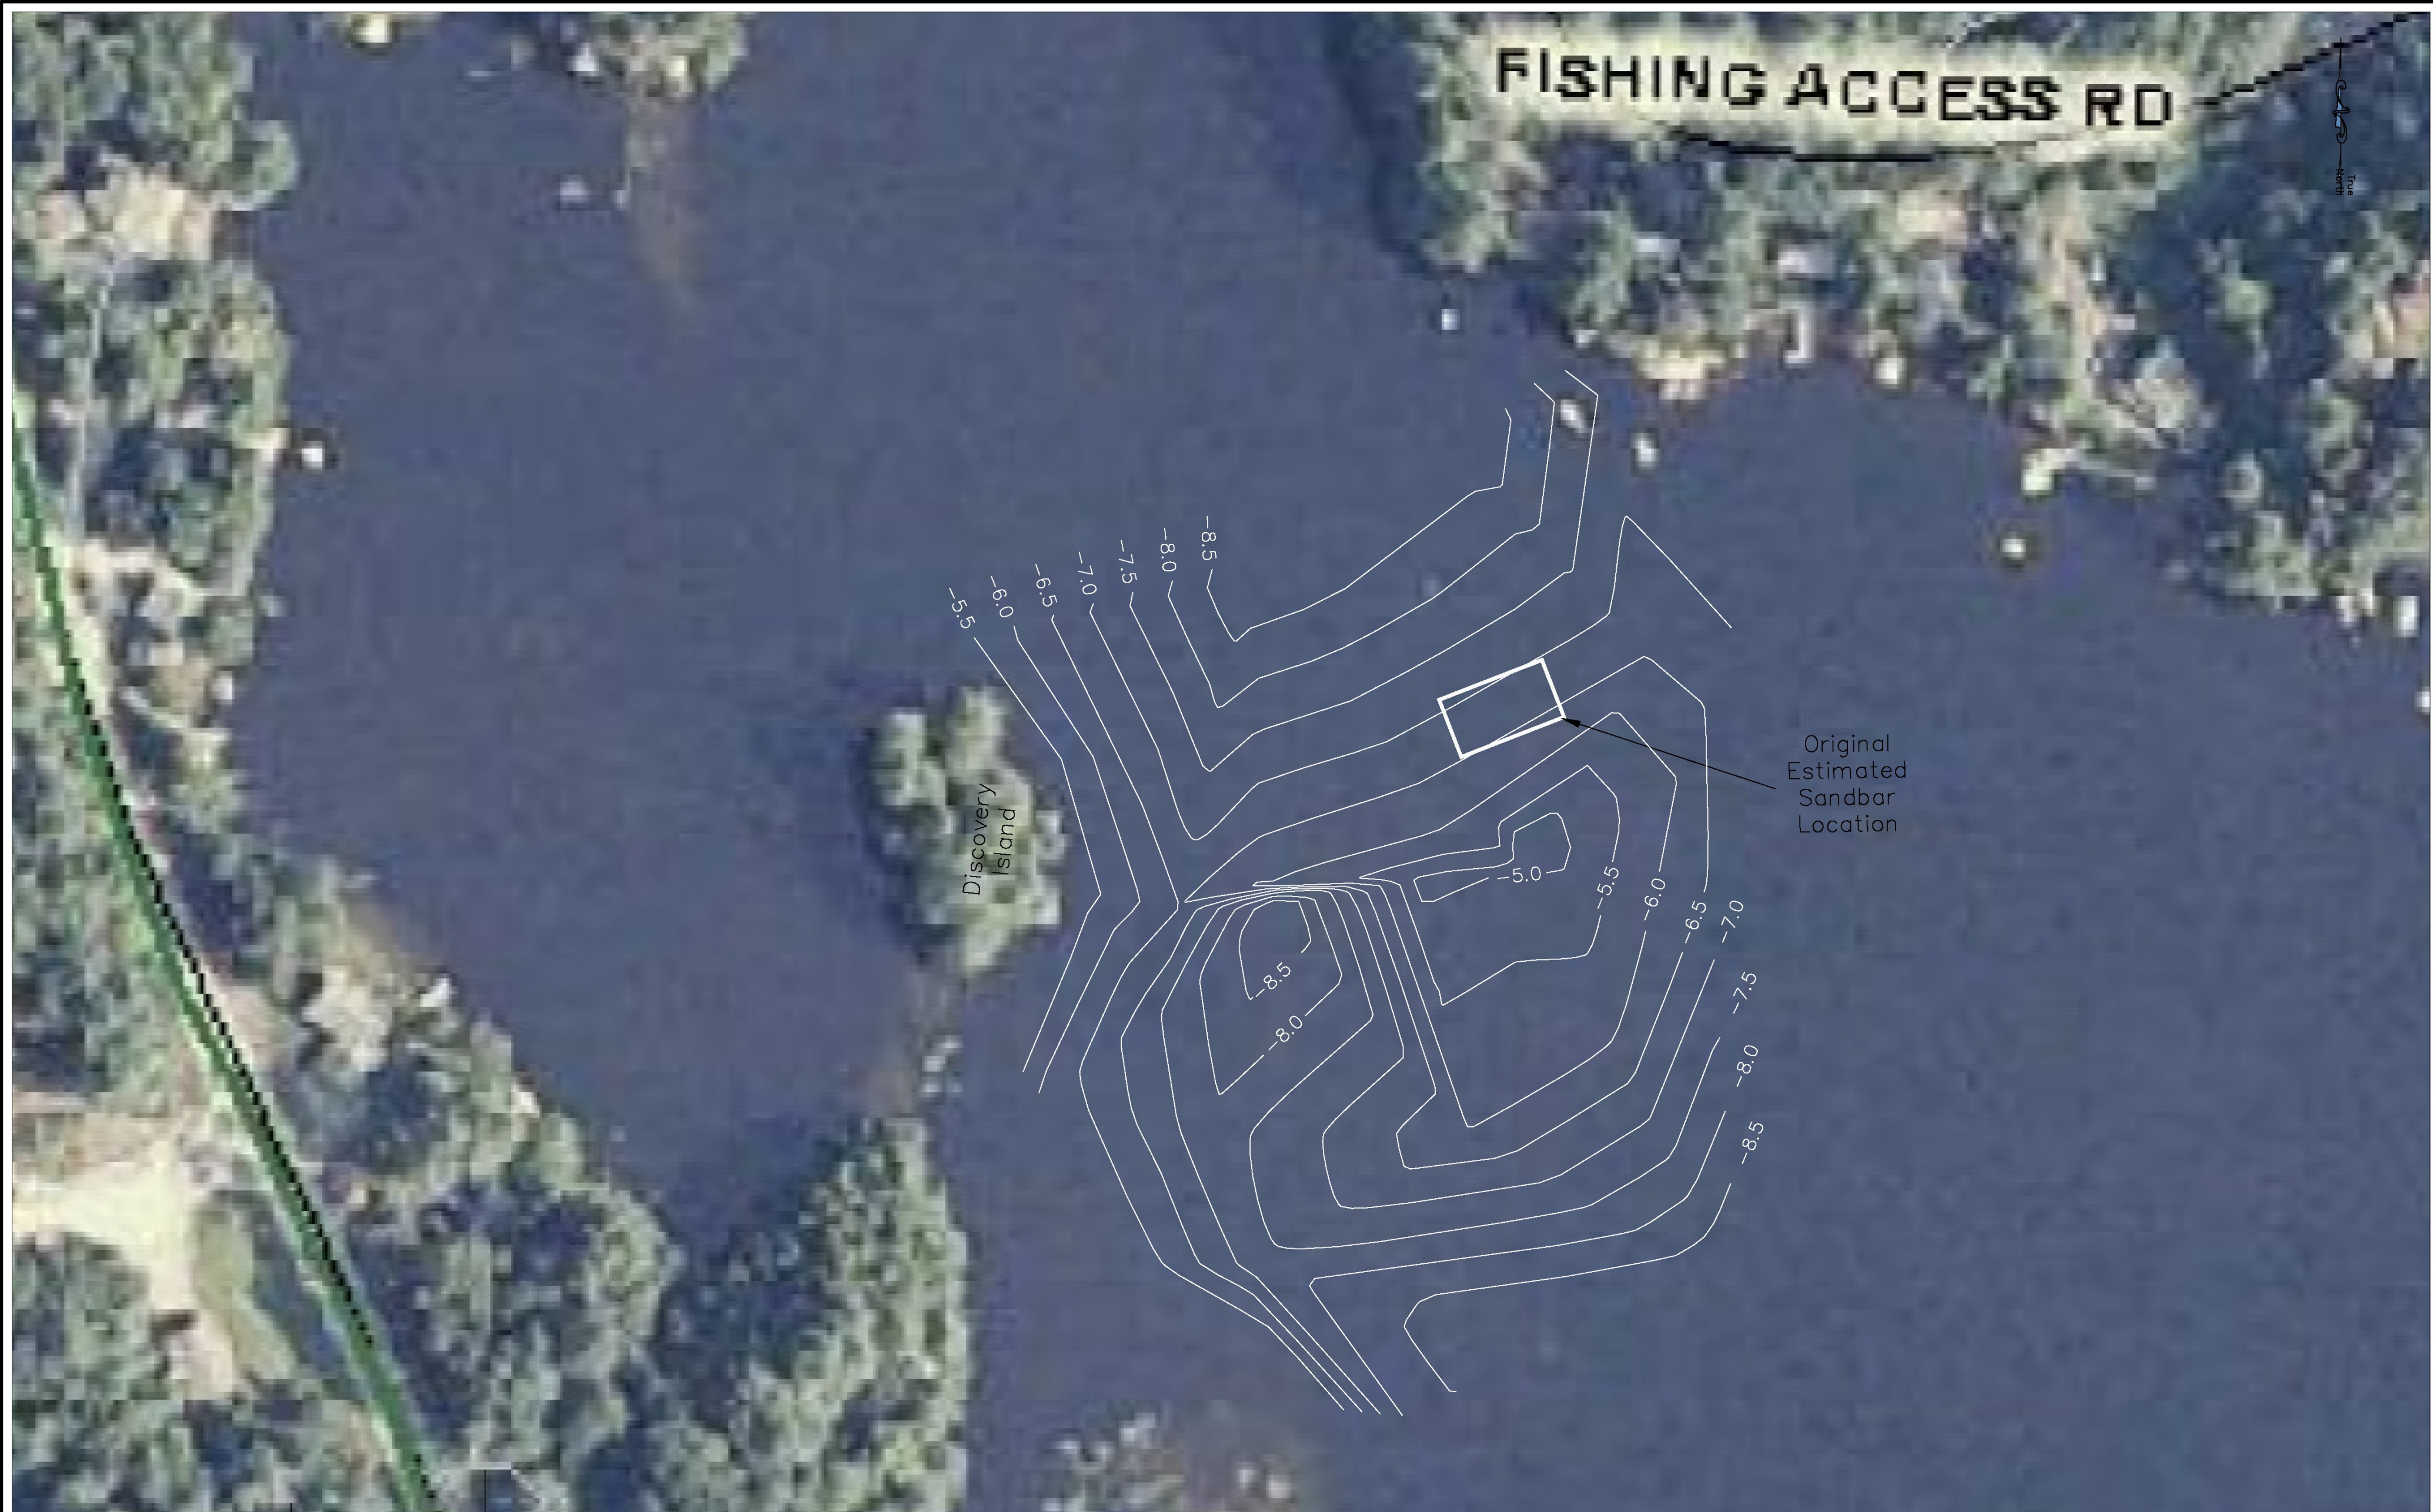
LAKE RESCUE ASSOCIATION
 LAKE RESCUE DREDGING PROJECT
 Town of Ludlow, Windsor County, Vermont
2013 EXISTING CONDITIONS
 -Discovery Island

The Sandbar east of Discovery Island shows very little change after adjusting for the 12 inch difference in lake level. Observed bathymetry of the “sandbar” adjacent to Discovery Island was consistently one foot deeper than measured in 2013. See charts E and F
