**Lake Rescue
Town of Ludlow, Windsor County, Vermont**

BATHYMETRIC INVESTIGATION

November 26, 2018

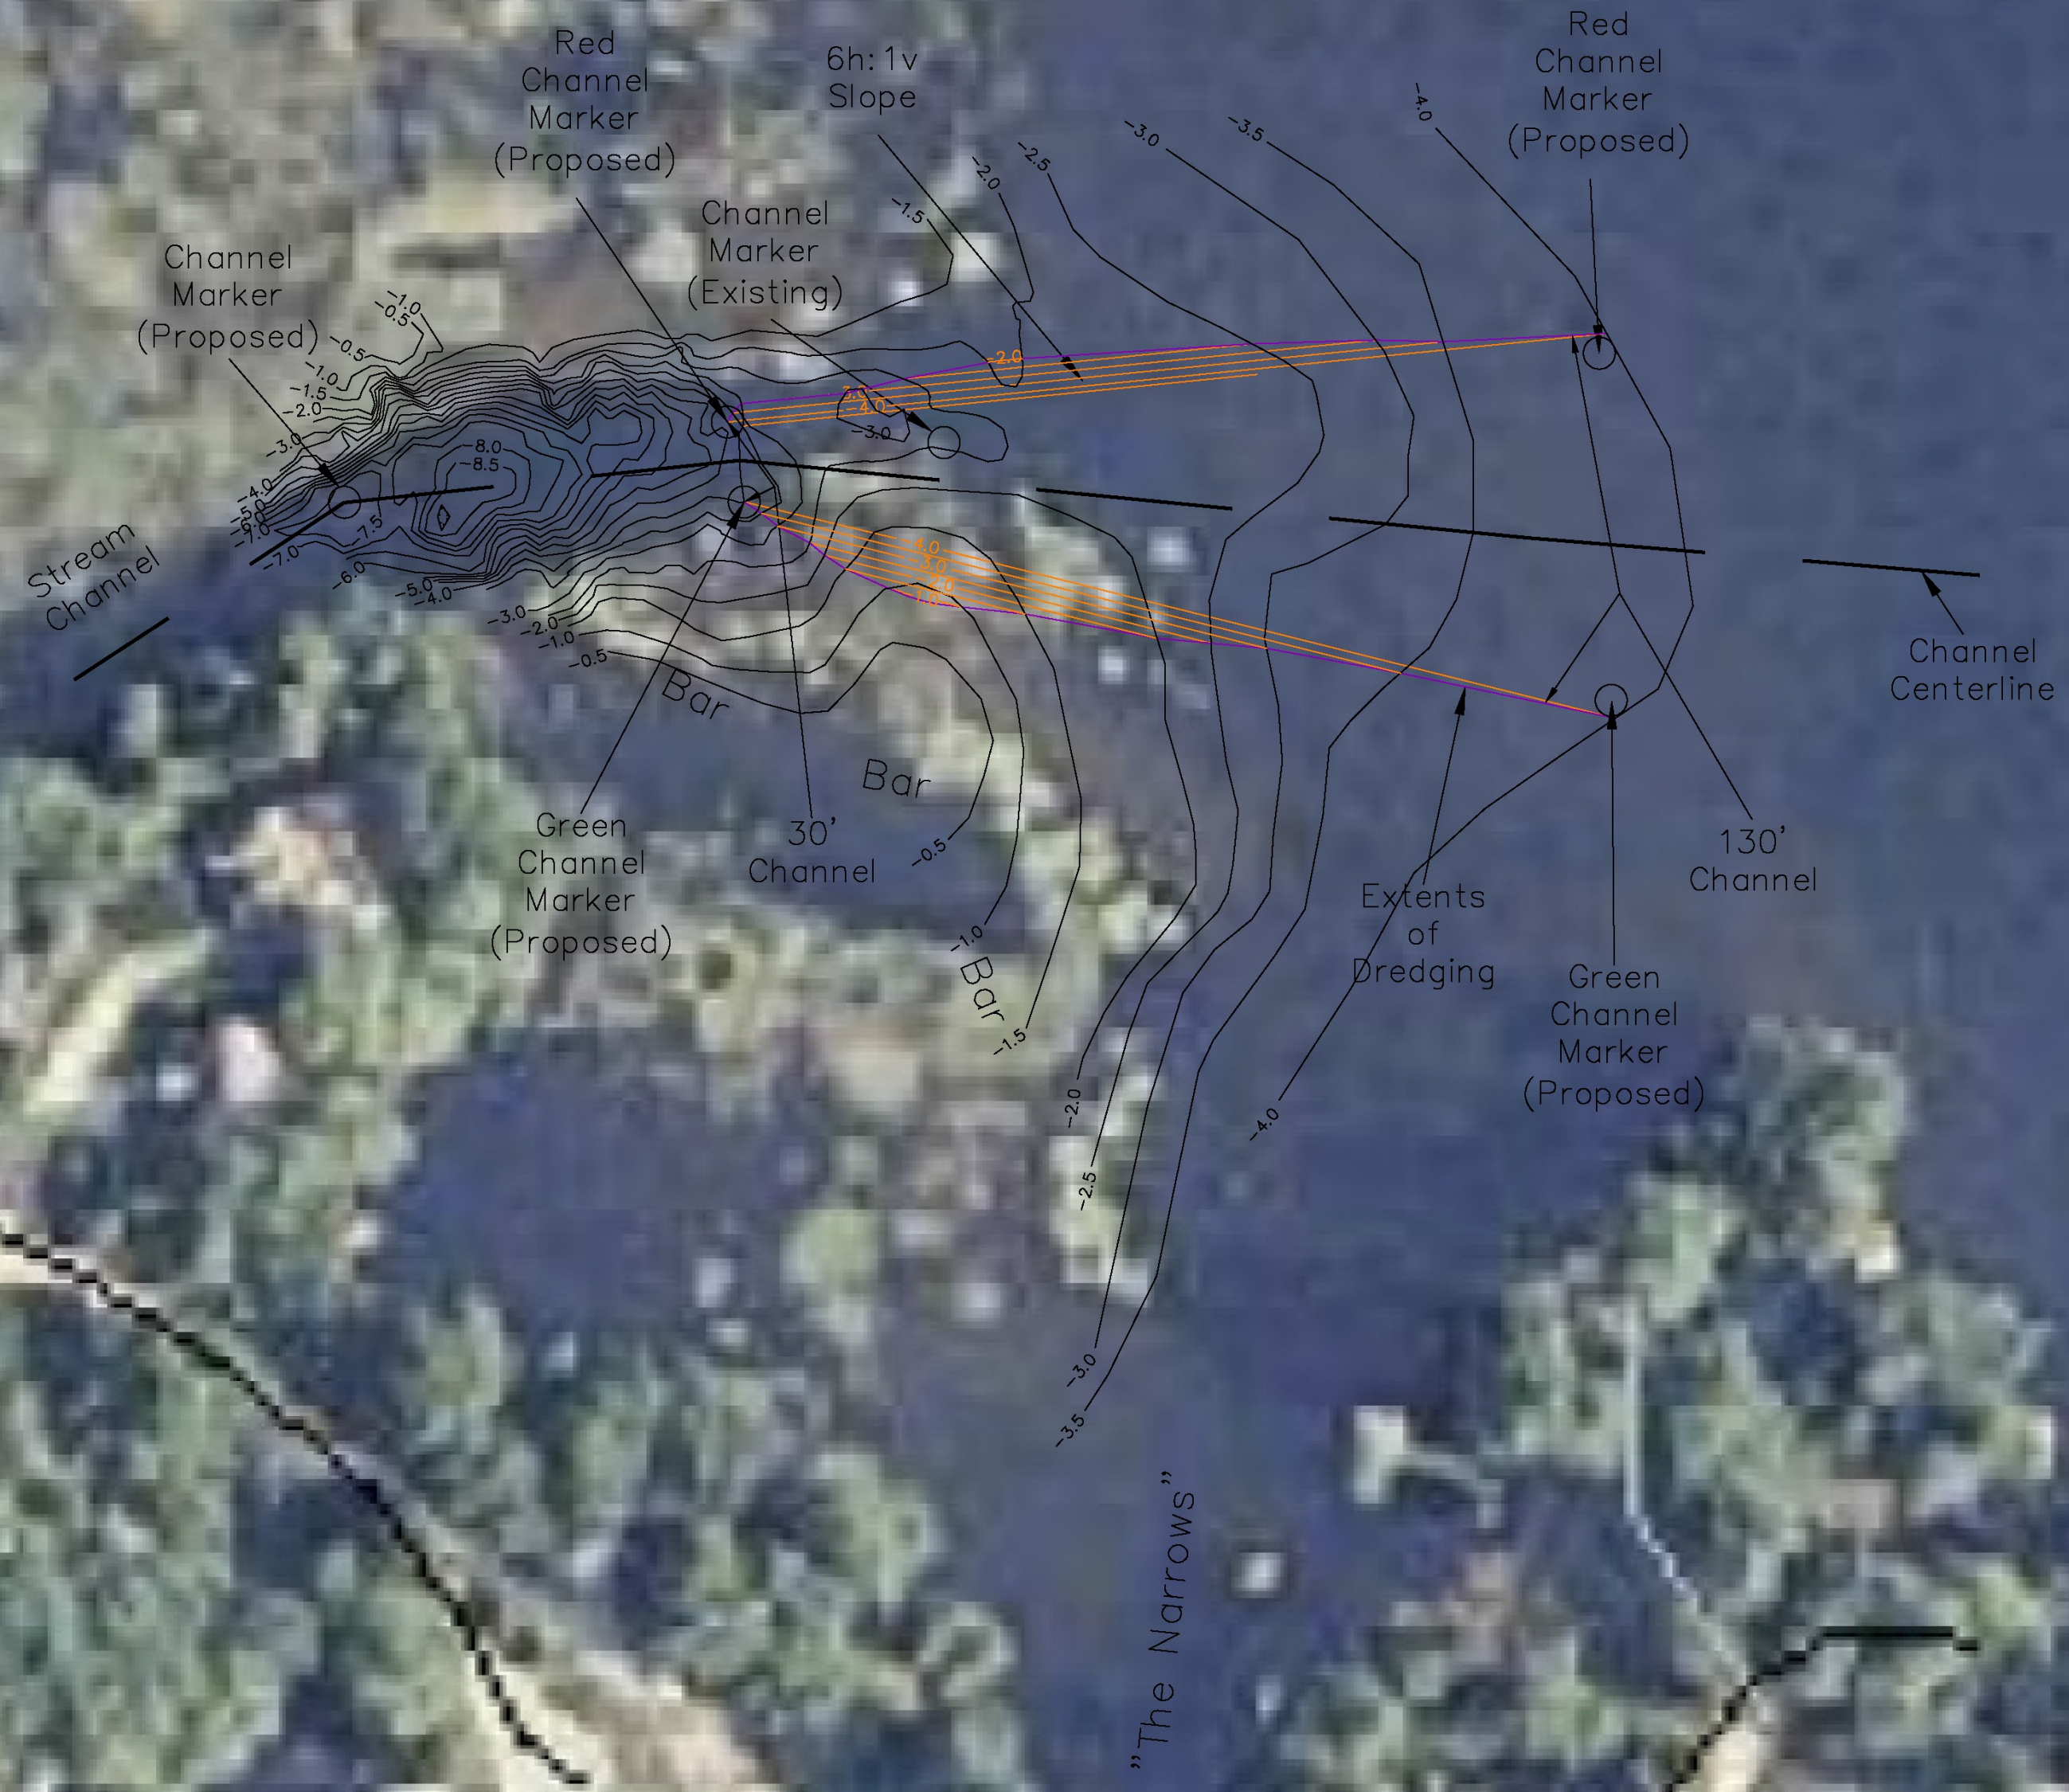
2013 DREDGING PLAN

Dredge a conically shaped channel as shown below to 4.0' below lake surface - 1200+/- C.Y.

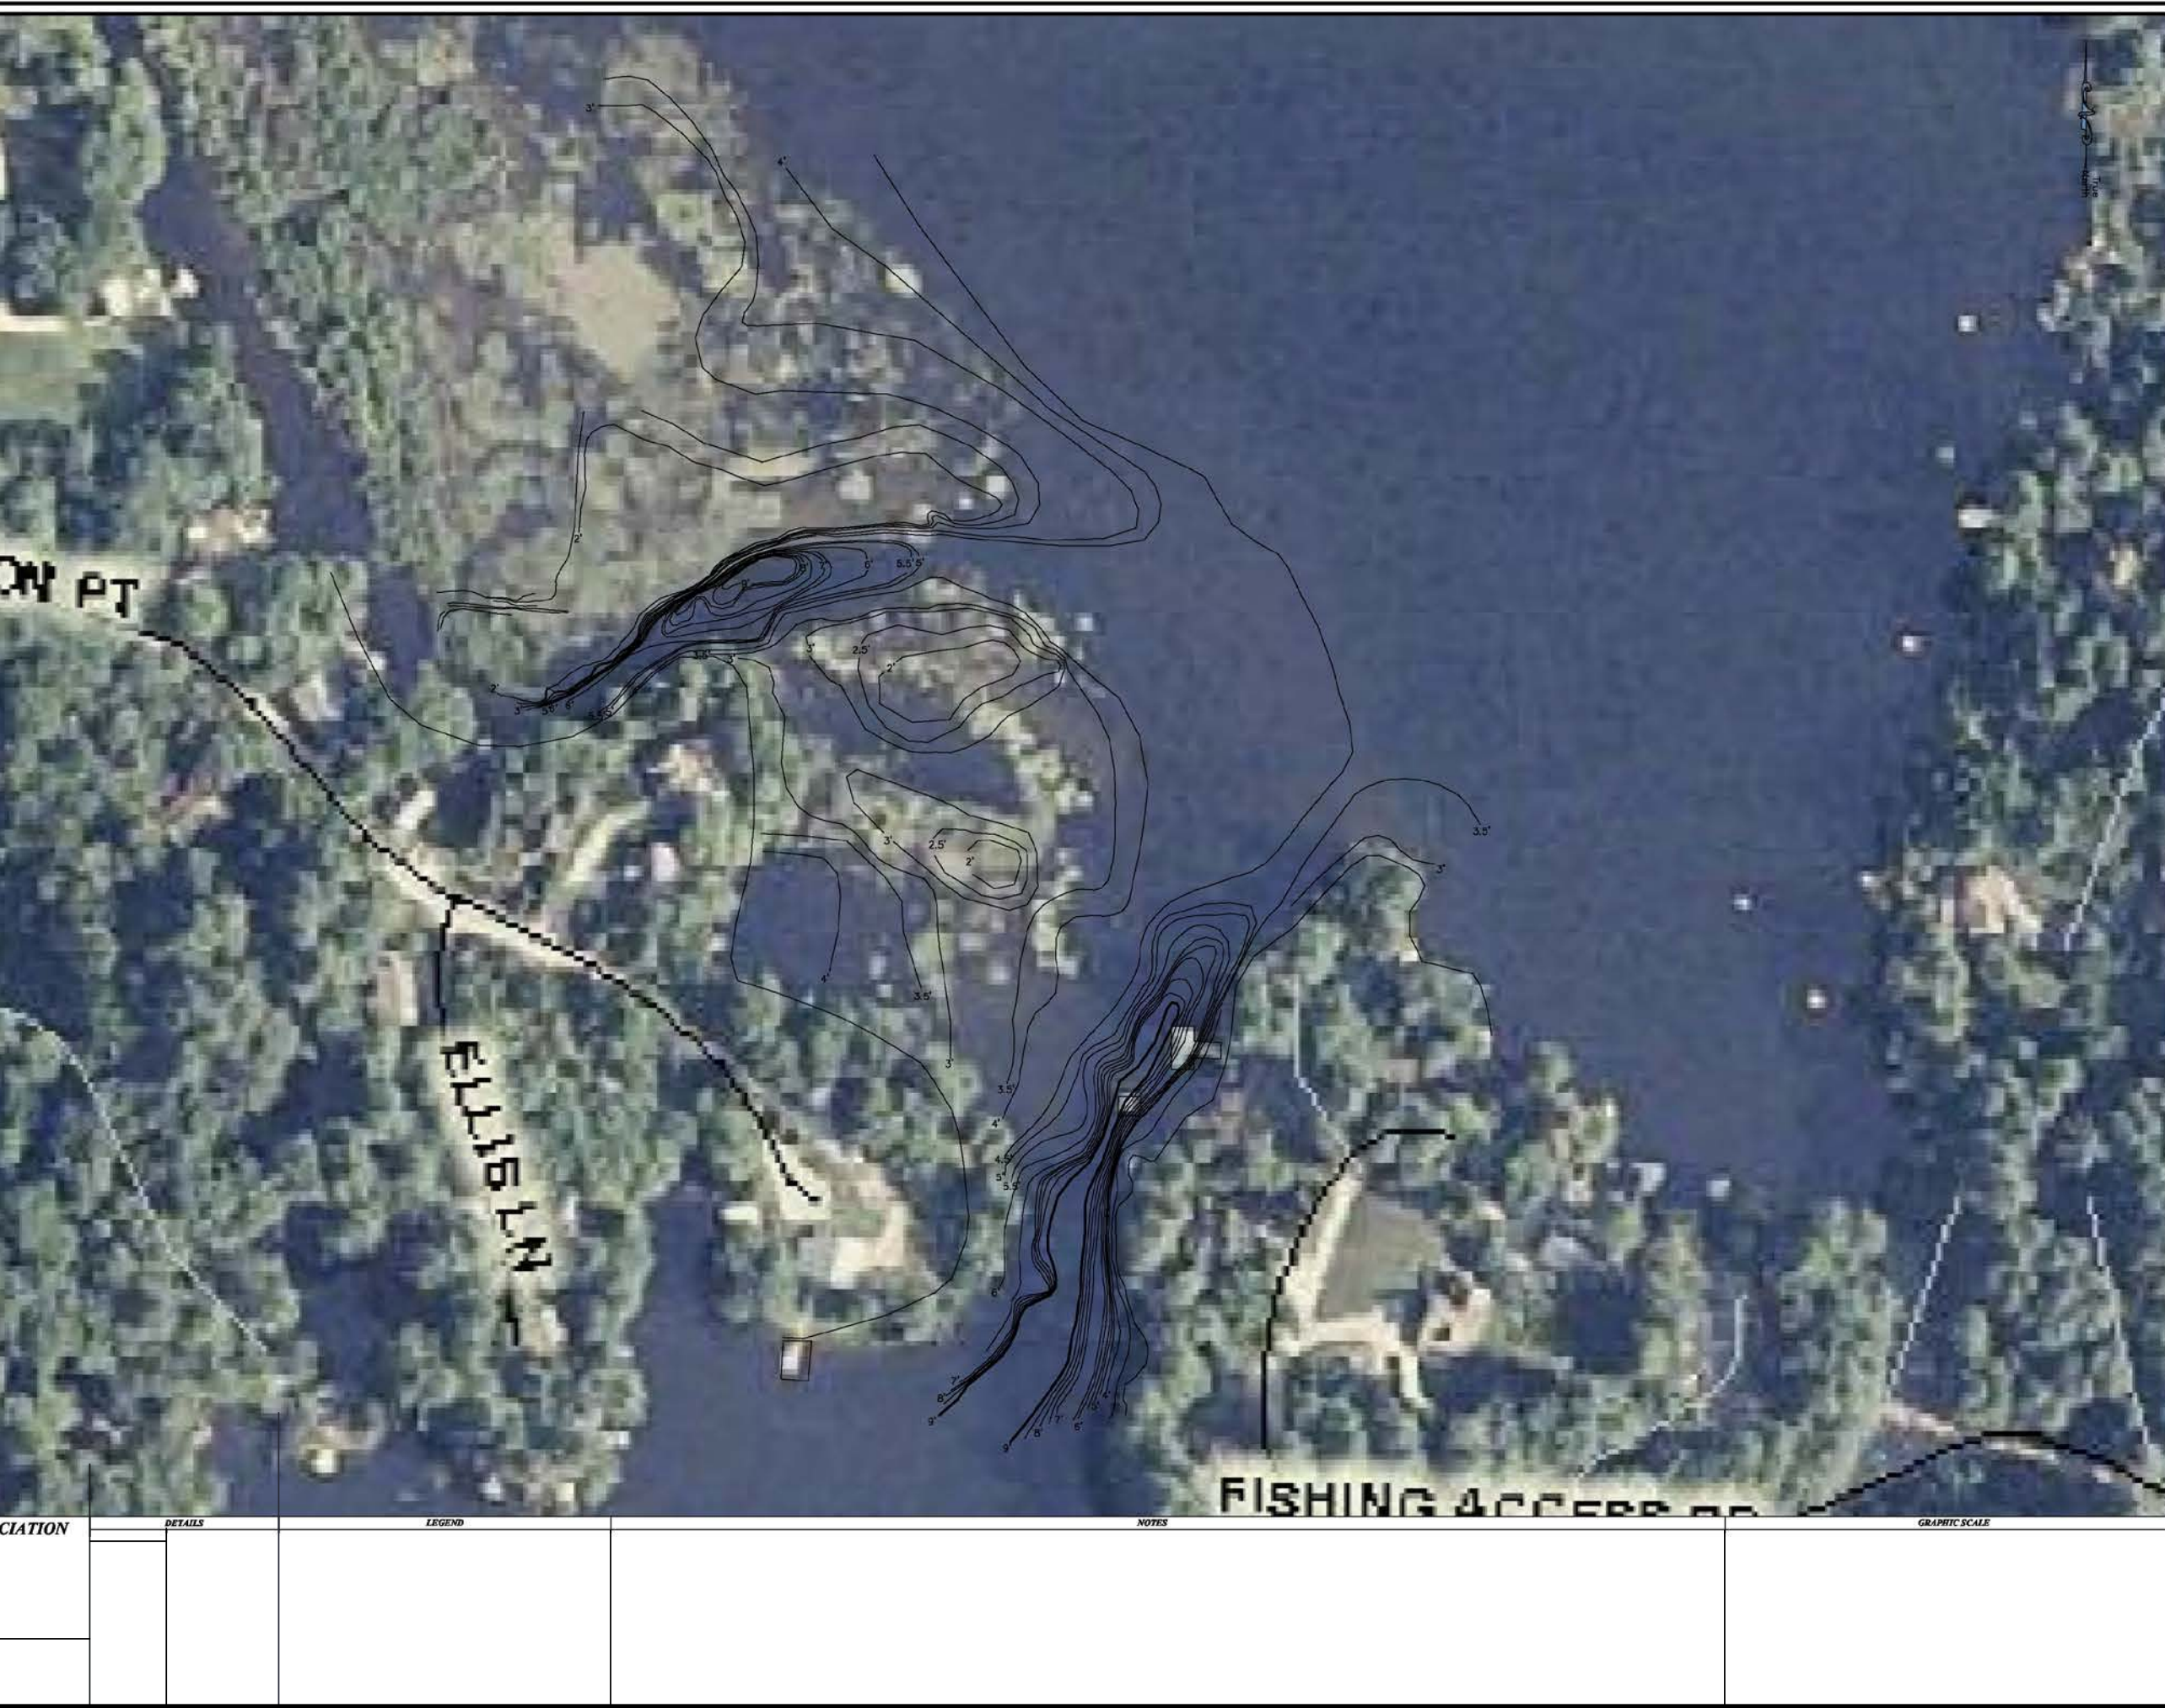
CHART C

LAKE RESCUE DREDGING PROJECT
 Town of Ludlow, Windsor County, Vermont
 2018 MATERIAL THICKNESS TO
 BE REMOVED - Restorative

Since the lake levels are approximately 12 inches higher Griggs-Lang recommends dredging to the 5-foot contours *at a minimum* to restore navigation in the river and the Narrows. The estimate of material to be removed to restore the depth of the lake in the general area of the 2012 Application is 1,980 cubic yards. The area of the estimate includes all of the area in the 2012 Application and additional area south of the river channel and north of the Narrows. The restoration would remove between 6 to 12 inches of sediment from the bottom of the proposed area, which covers approximately 69,017 square feet. (See Chart C)
