STATE OF VERMONT
DEPARTMENT OF ENVIRONMENTAL CONSERVATION
103 South Main Street, Building 10 North, Waterbury, VT 05671-0408
29 V.S.A. Chapter 11: Management of Lakes and Ponds

1. Name of Lake or Pond: **Lake Rescue** Municipality: **Ludlow, Vermont 05149**

Lake Rescue is located in Ludlow, Vermont on Route 100 North. (See map, Appendix A, page 6) . Please note that this proposal is an amendment to the application originally submitted in January, 2012 and includes important information obtained since that time.

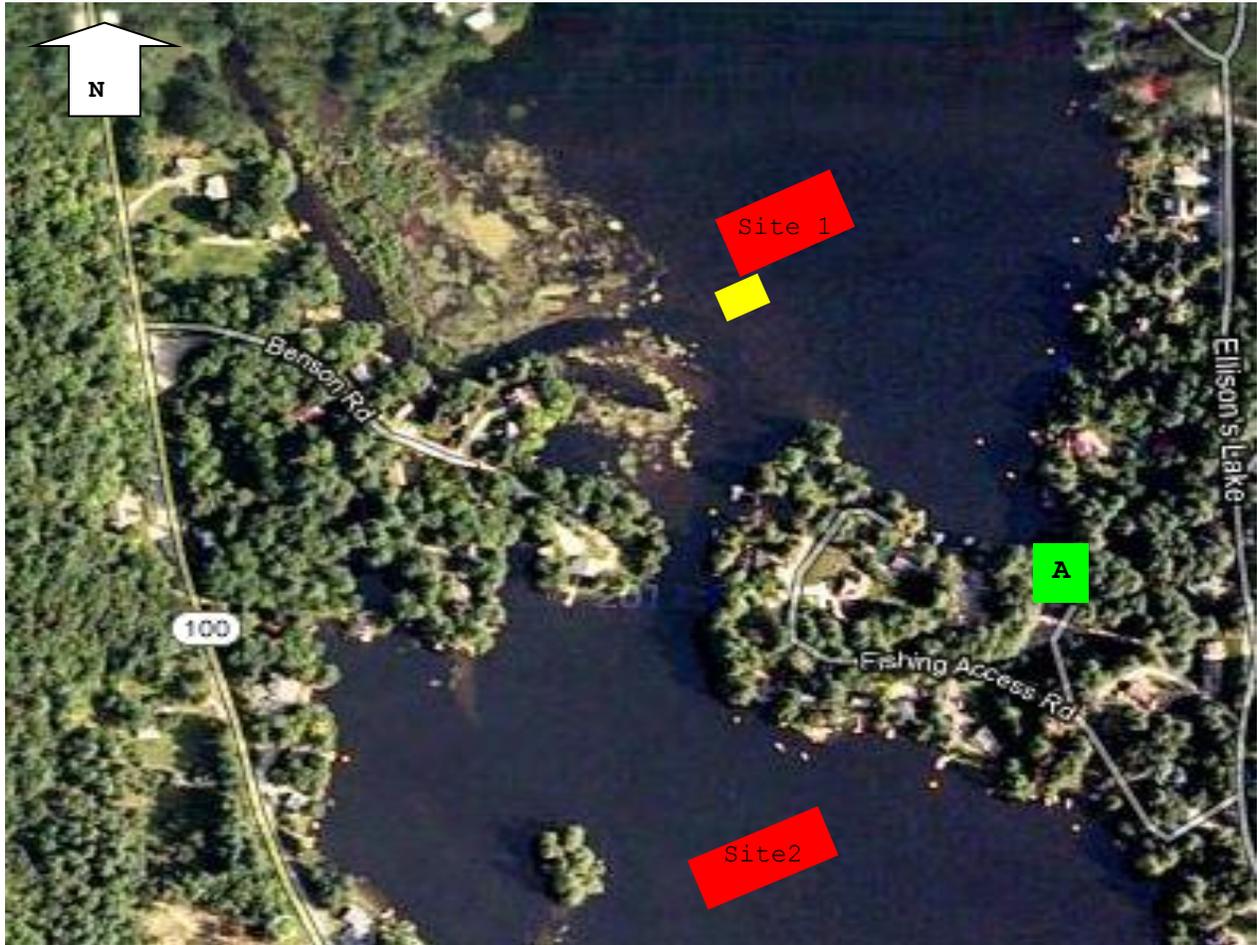
Appendix B: GOOGLE MAP SHOWING PROPOSED AREAS OF DREDGING AND DEWATERING.

The green box shows the proposed dewatering site at the state fishing access.

The yellow box shows the approximate location where the pontoon boat hung up on new sediment during the October, 2011 tour with ANR staff. Previous to Irene, such boats could enter the river.

The solid red boxes show the approximate locations of two new sandbar areas.
