Vermont Watershed Grants Project Year 2012

Name of Project:: Restoration of Black River tributaries north of Lake Rescue. This project continues the efforts of the Lake Rescue Association to control sedimentation of Lake Rescue/Round Pond, a natural lake on the Black River.

Project location & name of affected watershed or waterbody: Buffalo Brook and Reading Pond Brook, tributaries of the Black River in Plymouth, Windsor County. These streams, draining many acres of State Forest, contribute significant sediment to the Black River which deposits sediment in an ever growing delta in Round Pond (Lake Rescue). Following TS Irene, Lake Rescue and Round Pond have experienced huge deposits of sediment from the river including two new sand bars. To this day the lake water remains brown with suspended sediment (Figure 1). Addressing sediment sources in these streams will protect the water quality of both Echo Lake and Lake Rescue while improving instream habitats and flood resiliency.

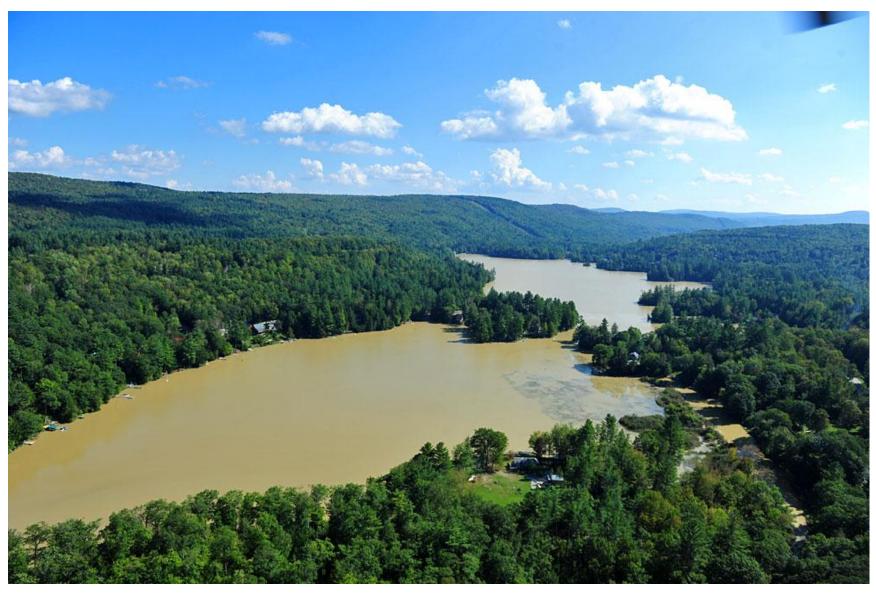
Figure 1. Round Pond (foreground) and Lake Rescue in the days following Tropical Storm Irene. These instream lakes on the Black River continue to run turbid, due to ongoing channel work along upstream reaches and tributaries in the town of Plymouth.

- 3) The underlying project impetus is to restore the water quality of the downstream lakes on the Black River, particularly Lake Rescue which serves as a major sediment collection site due to peculiar river geography: the river takes a full right angle turn east just before entering Round Pond, slowing, dumping sediment, and then turning another 90 degrees south to enter the channel to Lake Rescue and again depositing sediment which has created a new sand bar, post Irene, in what was 12 ft of open water.

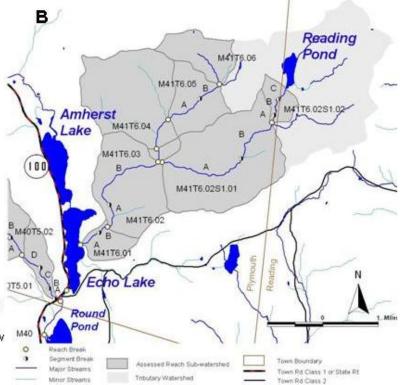
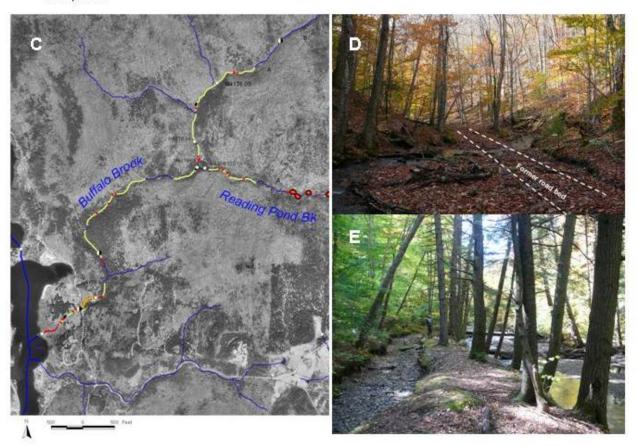
Figure 2.

- Location of Study Area within Black
 River watershed.
- B. Location Map, Buffalo Brook tributary watershed.
- C. Pale green highlighting indicates channel with abandoned forest road within one channel width to either side of the stream.
- D. River crossing old road bed, which now functions as a flood chute, 2009.
- Recent avulsions along former forest road, 2009.

improved forest management practices and stream restoration projects in the Buffalo Brook watershed, in collaboration with VT Departments of Forests, Parks & Recreation, and Fish &Wildlife and the Towns of Plymouth and Reading. This area is largely undeveloped forest land in state and private ownership, crisscrossed by old roads no longer maintained. A pre-Irene geomorphic assessment identified abandoned road segments as a significant source of sediment (Figures 2D, 2E). A possible goal will be to "re-wild" the roads to prevent excessive erosion.
